# Silo Condition Inspection Report

Silo Ridge Golf Course  
Amenia, NY

**RENNIA ENGINEERING DESIGN, PLLC**  
**CIVIL & ENVIRONMENTAL ENGINEERING**

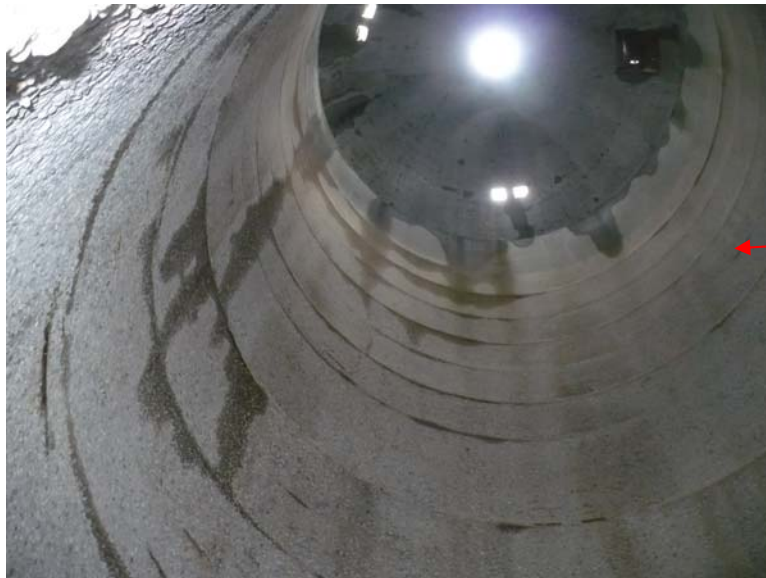
Silo Interior Upper Section

The interior portion of the roof appears to be in good condition as well with no cracking, spalling, or deterioration.

NO  
SPALLING

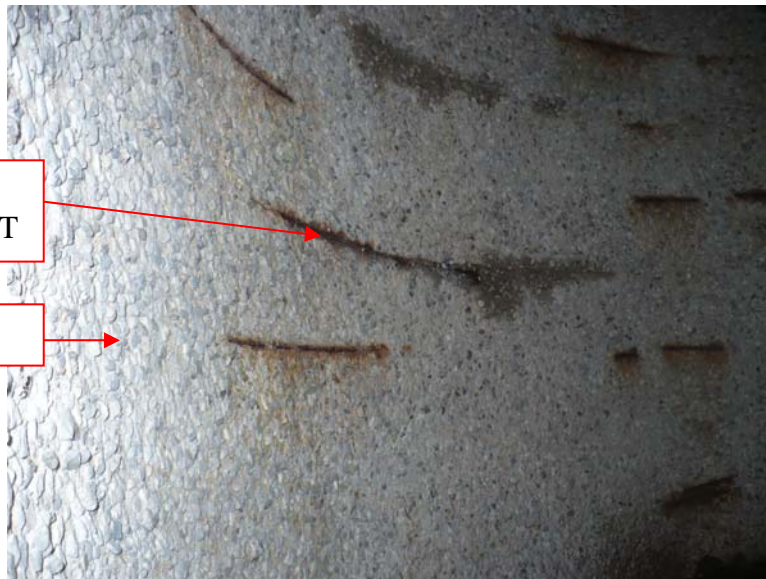
Silo Interior Lower Section

Overall the existing silo interiors are in good condition. The interior of the silos have some visible spalling on the lower halves of both silos. The upper halves of the silos have little to no visible spalling. The spalling was likely caused by the breakdown of the vegetation being stored in the silos. The stored grain ferments over time and creates an acid that will corrode concrete and other materials.

The spalling which is a pitting or flaking of concrete, is in this case superficial in nature and does not appear to have affected the structural stability of either silo.

As a result of the spalling exposed steel reinforcement is visible in multiple locations. The exposed reinforcing bars appear to have only surface rust and appear to be structurally sound.

RUSTING  
REINFORCEMENT

SPALLING

The spalling repair should include at minimum the following:

1. Remove any loose material with a high pressure water spray.
2. Wire brush the reinforcing bars to remove loose scale and coat with a rust inhibiting coating formulated to adhere to rusty surfaces.
3. Apply a surface hardener to the spalled concrete face.

4. Apply a bonding agent to the spalled concrete face.
5. Coat the remaining spalled concrete with a high strength ( $\geq 5,000$  psi) masonry cement mixture that is either trowel or spray applied to a minimum thickness of 1-inch.

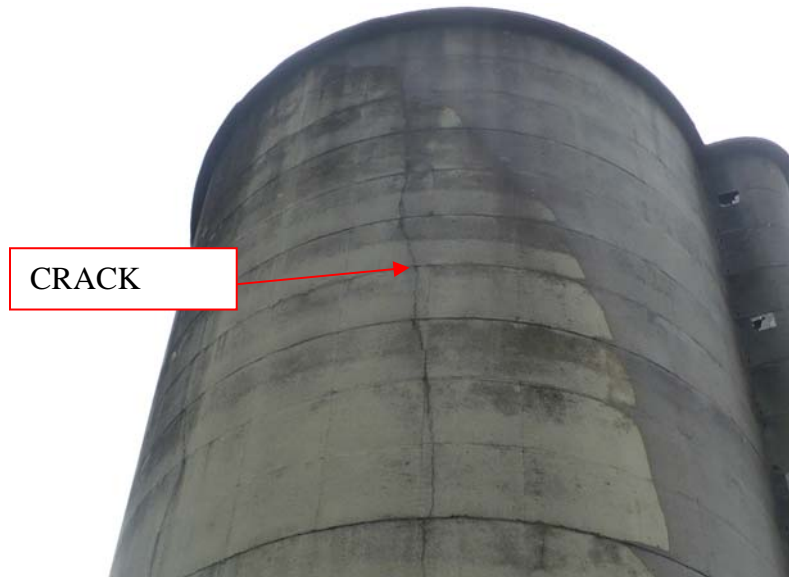
Silo Exterior

The exteriors of the silos were also found to be in good overall condition. Some minor cracking on the exterior of the silos is visible. The cracks appear to be stable and have not moved in many years.

The exterior foundation zone appears to be in good condition as well with no visible cracking or settlement. Additionally the area appears to be well drained.

The crack repair should include at minimum the following:

1. Remove any loose material with a high pressure water spray.
2. Router out the crack to 1/4" x 1/4".
3. Apply a concrete caulk such as Sikaflex 15 LM.

In addition to the above repairs we also recommend the cleaning of the exterior walls and application of a masonry water proofing compound such as Sure Klean Weather Seal Siloxane PD.
