Amenia New York

Visual Character -1 Existing:

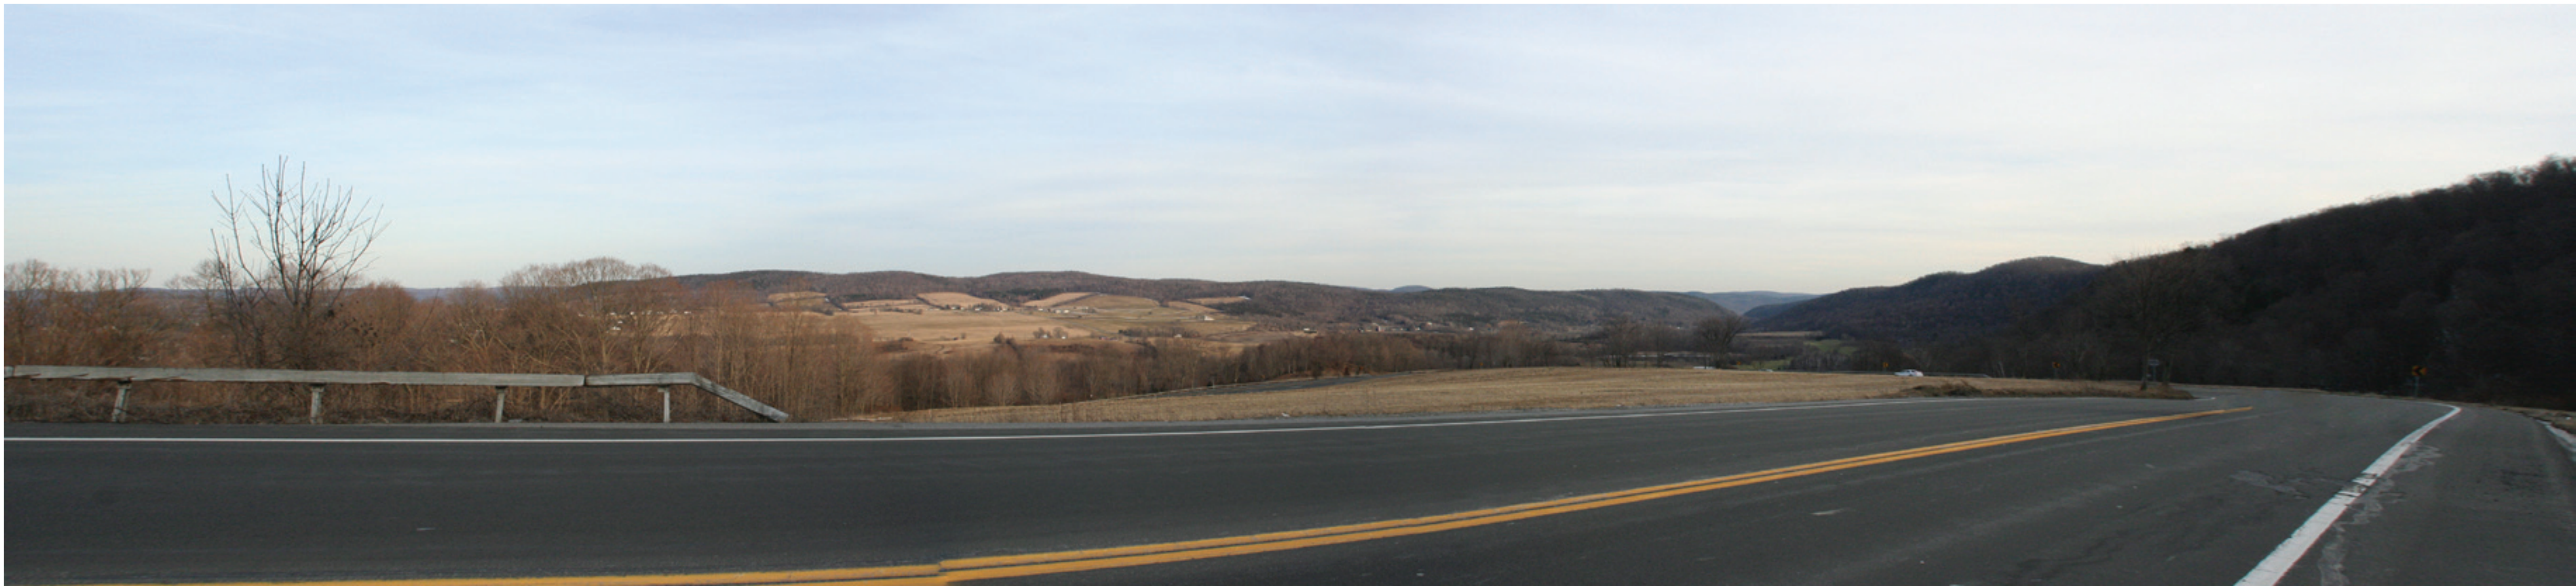
This is the dramatic, unfolding, panoramic and historic view that defines entry into Amenia along Route 44 from the west; and this view shed has been identified as a priority for protection by the Town. The low domed form of DeLavernge Hill, covered in meadow grass with Route 44 snaking around its base, controls the foreground view. The golf-course landscape in the middle ground, right of center, is visible. The yellow/brown, grass covered landfill is visible above the golf course. The background is dominated by the natural skyline of folding hills with their interface of dark hued hilltops defined against the bright sky to the south and the agricultural landscape on the opposing face of the defining hills to the east and southeast. Approximately 40 structures including homes, farmsteads and agricultural buildings, are visible on the face of the opposite hills. This view is full of the visual characteristics and patterns that define this region.

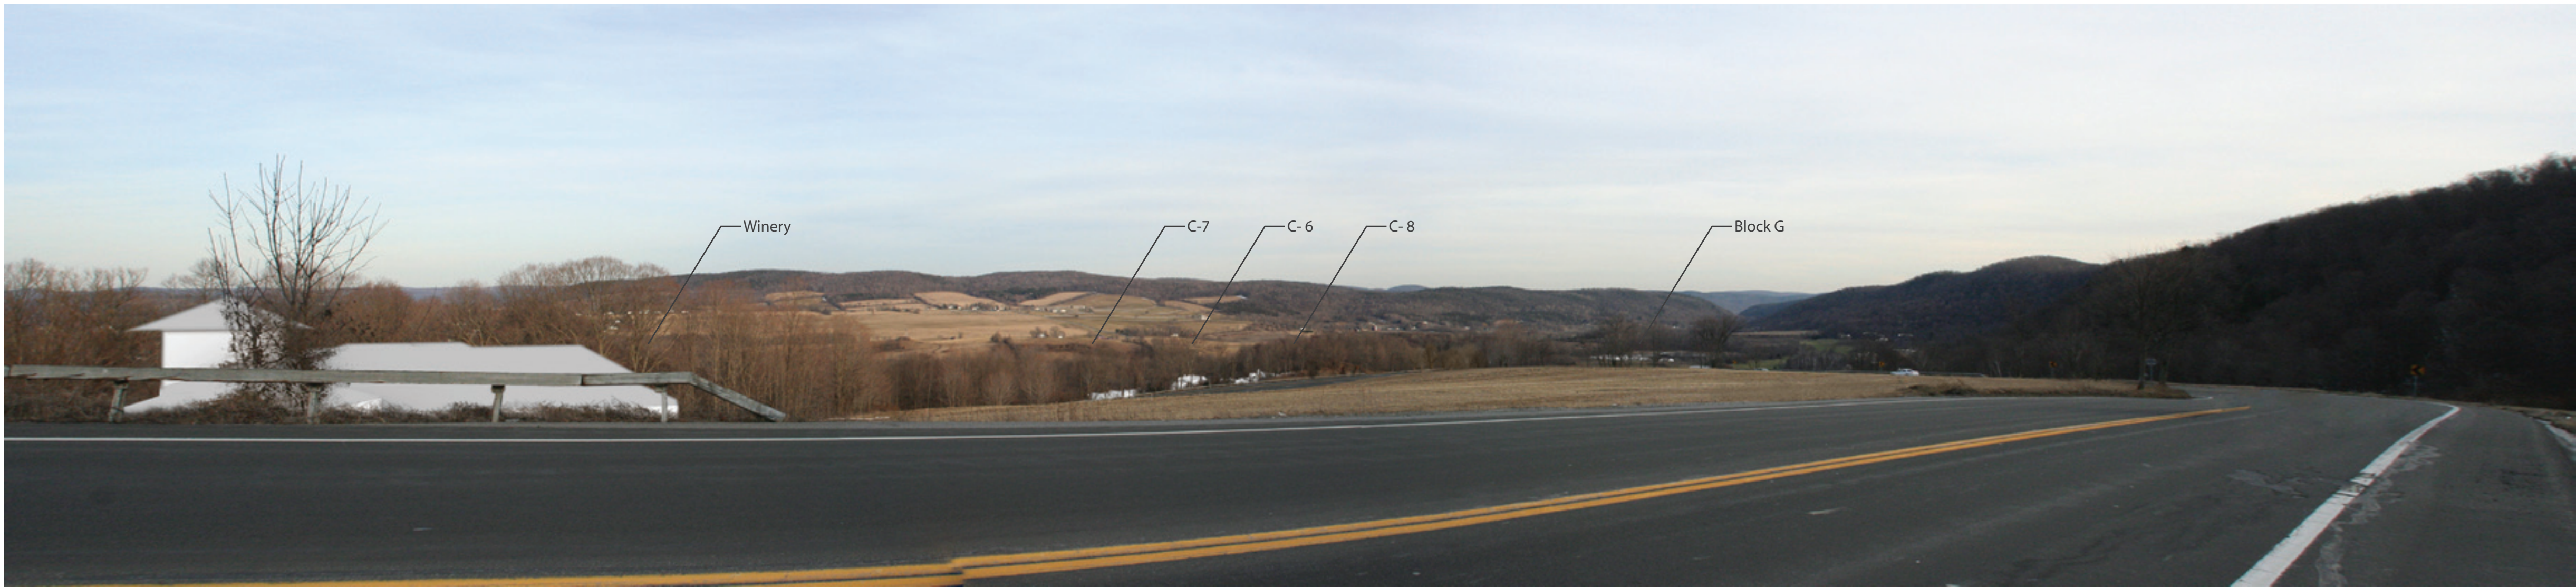
Visual Character – 1 Developed/Unmitigated:

The winery restaurant roof, depicted in the unmitigated white/gray color, is evident and discordant against the wooded backdrop. The winery restaurant is in the view but does not obscure the view of the fields to the east/ southeast. The south face of the winery building is 530+ feet from the inside apex of Route 44 hairpin curve. This building location is an additional 145’ further north than what was presented in the October 4, 2007 DEIS. The winery building location is north (left) of the guard rail in the foreground and north of the front edge of the trees behind the building; these trees partially screen the existing homes, hills and fields beyond. The First Floor Elevation (FFE) of the Winery Restaurant is 28 +/- feet below the road elevation at the entry drive. The FFE places the main façade of the building physically and visually below the road from this viewpoint leaving the roof and cupola visible.

Buildings C6, C7 and C8 are visible, in the unmitigated white color, slightly left of center in the picture. The point to where the heights of the above buildings are measured to is 167’, 164’ and 158’, respectively, below the view-

point elevation of 830’. The unmitigated white buildings are within the view but are visually below the mid-ground tree line and do not block the view of the fields and hills in the distance.

The Block G buildings in the distance, visible just over the foreground field slightly right of center, can be compared to other existing structures within the view shed, which have white aspects to them, but Block G is lower in elevation visually from this viewpoint than the buildings on the opposing hillside. The point to where the tallest height of any building in Block G is measured is 277’ below the viewpoint 1 elevation of 830’.

In the distance to the right of the landfill, 4 white colored unmitigated single family homes are visible. These homes are approximately 6,000’ away from the viewpoint. The point to where the tallest height of these homes is measured to is 143’ below the viewpoint elevation. These can be compared to other structures within the landscape relative to scale and color. These 4 homes were previously more centrally located visually below the landfill and to the right of Block G in the DEIS plan but have been relocated off center of the view down the valley into the woods to the west in the April 3, 2008 MDP.

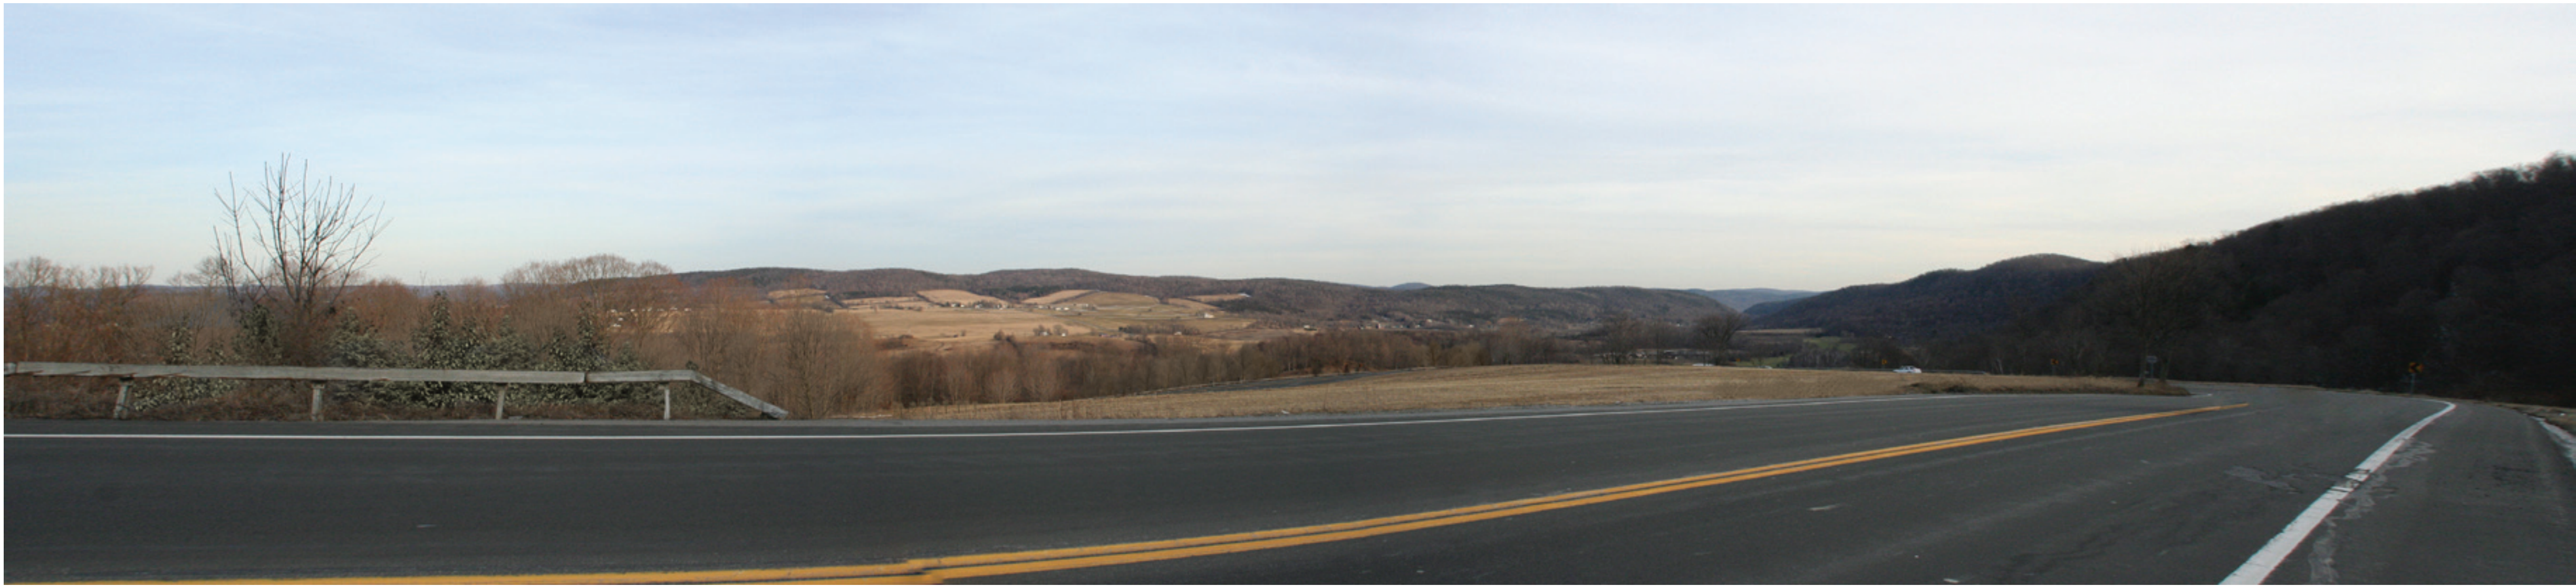
Visual Character – 1 Developed/Mitigated:

Through the use of subdued tones for architectural roofs and facades and planting materials that both screen and break-up building mass, site structures are reduced in impact. The view is still dramatic, unfolding, panoramic and defining of the region.

The winery restaurant is not visible due to landscaping placed between the guard rail and the building. As depicted in the cross section, included in the assessment for this viewpoint, the landscaping is placed such that the height of the landscaping from a visual perspective does not break the existing tree line directly behind the winery to the east. The trees behind the winery building are to remain.

Buildings C6, C7 and C8 are not visible in the image due to the natural building colors and landscaping. The existing treed knoll to the right of these buildings is proposed to be extended to the left to provide screening. The

proposed extension of the wooded knoll will not block views to the distant hills, due to the drop in elevation of the topography. The approximate average elevation that these trees are proposed to be planted is 160’ below the viewpoint elevation. All of the trees on the western portion of the existing treed knoll are intended to remain. A “limits of disturbance” will be established around these trees to protect them.

The 4 single family homes at the southern end of the site are reduced in impact in this image.

The ridgeline remains continuous and the current unobstructed view to the distant hills remains unobstructed from this vantage point.

Quantification: 0.50% or less of the overall image contains proposed mitigated structures.
